# **A DESIGN APPROACH TO ENVELOPE REMEDIATION OF HERITAGE BUILDINGS: FIELD MONITORING OF SALT BUILDING**

**Hamid Heidarali, P.Eng., Sophie Mercier, P.Eng.**  
Morrison Hershfield Limited

## **ABSTRACT:**

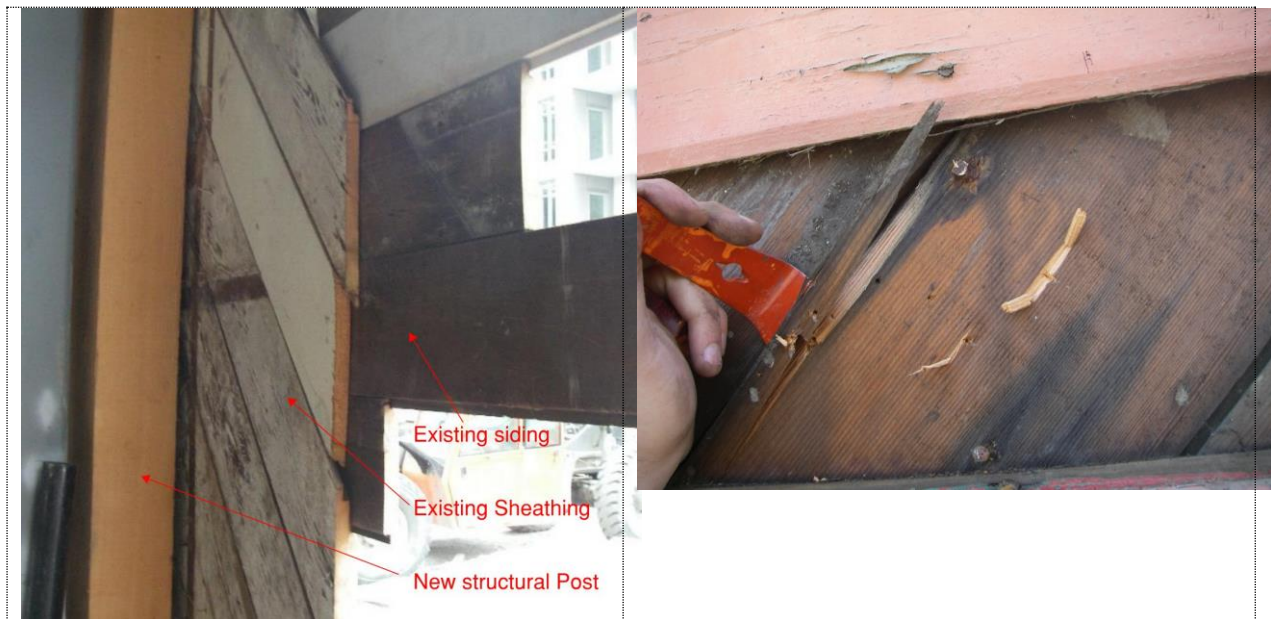
During the investigation of the condition of the existing walls, it was found that the walls with no insulation, air, vapour and moisture barrier - as original construction wall assemblies - were still in good condition. Some horizontal cedar siding was removed to allow for close review of the diagonal sheathing condition. Except for some staining at the nail penetrations and some splitting, the sheathing and cedar siding were generally in good condition (Photo 4). The wood framing, which could be easily observed as it was exposed to the inside, was also in good condition. This was not the case for the modified walls. Where insulation and vapour retarder were installed at the conditioned section of the building, the walls were heavily deteriorated with the cladding, sheathing and stud framing completely rotten at the base of the wall.

*Photo 3: Original wall assembly viewed from the inside*

*Photo 4: Existing sheathing viewed from the outside*

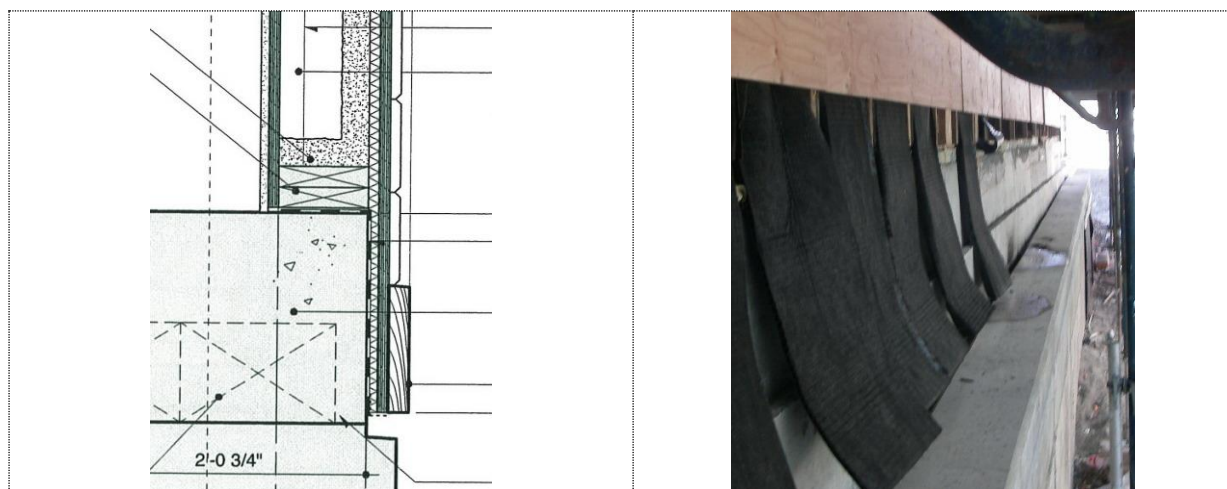
Figure 1 & Photo 5: Drainage mat detail at the base of wall

To achieve the ventilation inboard of the sheathing, it was proposed to install a drainage mat at the inside of the building to the back of the sheathing. That drainage mat would be installed in each stud cavity (from stud to stud), and be connected to the exterior at the bottom and at the top to allow for venting inboard of the sheathing. The latter would involve a small amount of disturbance to the cladding and sheathing but it was felt to be necessary. At both locations, a few feet of the existing cladding and sheathing would need to be removed. Before removal, the cladding would be marked in order to be reinstalled in the same location. The sheathing would simply be discarded and replaced with new pressure treated plywood at the base (Figure 1 and Photo 5) and an additional layer of drainage mat at the top (Figure 2 and Photo 6).

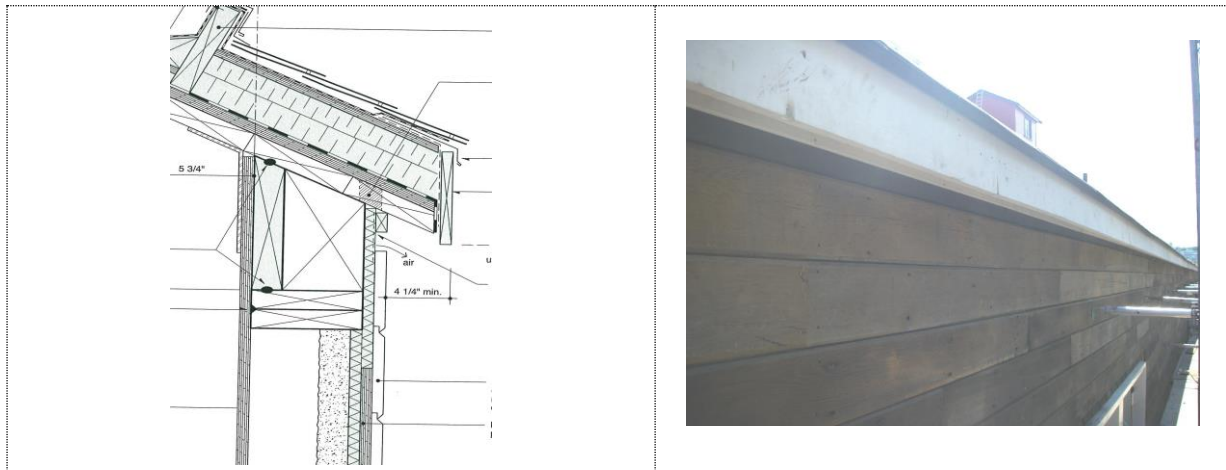
*Figure 2 & Photo 6: Drainage mat detail at the top of wall*

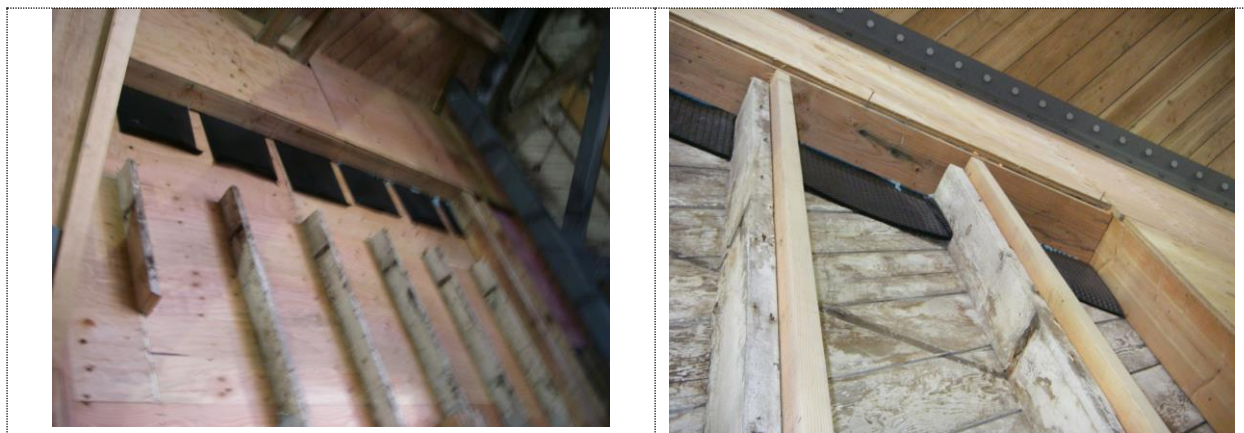
*Photos 7 & 8: Structural upgrades of the studs and new pressured treated plywood on the inside*

As a first step, the wall structure needed to be upgraded to meet the seismic requirements. This was, in part, accomplished by sistering the existing 2x6 wood studs with new 2x8 pressure treated wood studs and eventually adding a plywood sheet on the inside face of the wall as a finish (Photos 7 and 8). The structure also needed to be modified to accommodate the venting at the bottom of the wall. Principally, this consisted of notching the base plate to accommodate the drainage mat to go through.

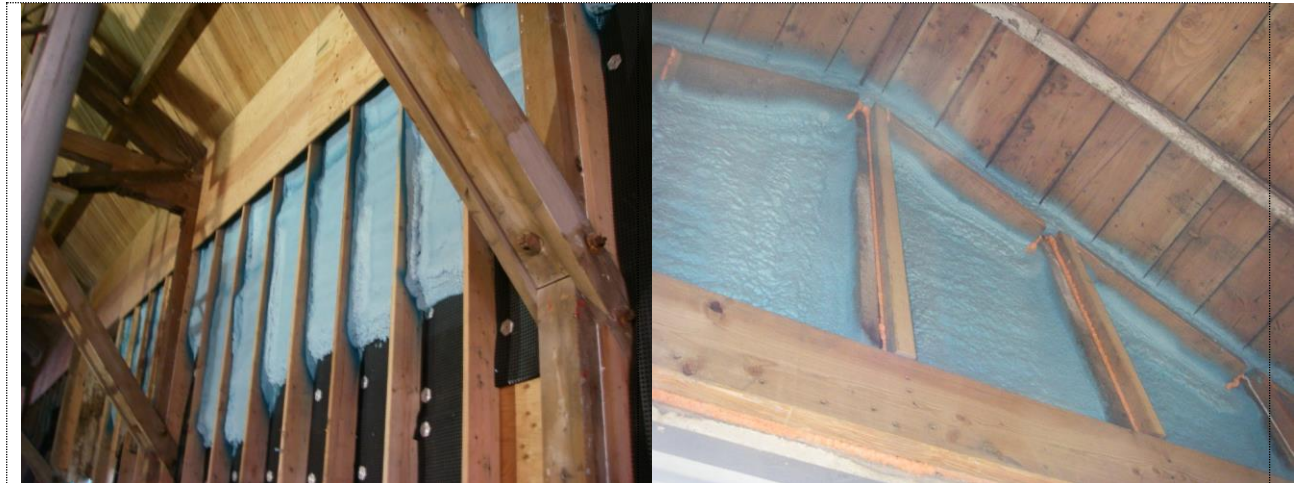
*Photo 9: Closed Cell Polyurethane foam against drainage mat      Photo 10: Gaps between studs are sealed*

Medium density, closed cell, spray applied polyurethane insulation was chosen to provide the thermal insulation, air barrier, and vapour diffusion control for the exterior walls (Photos 9 and 10). Considering the number and type of penetrations in the wall for structural and service purposes, the concept of using fibrous insulation and sealing the interior sheathing or vapour retarder to form an air barrier was judged to be a more problematic alternative.

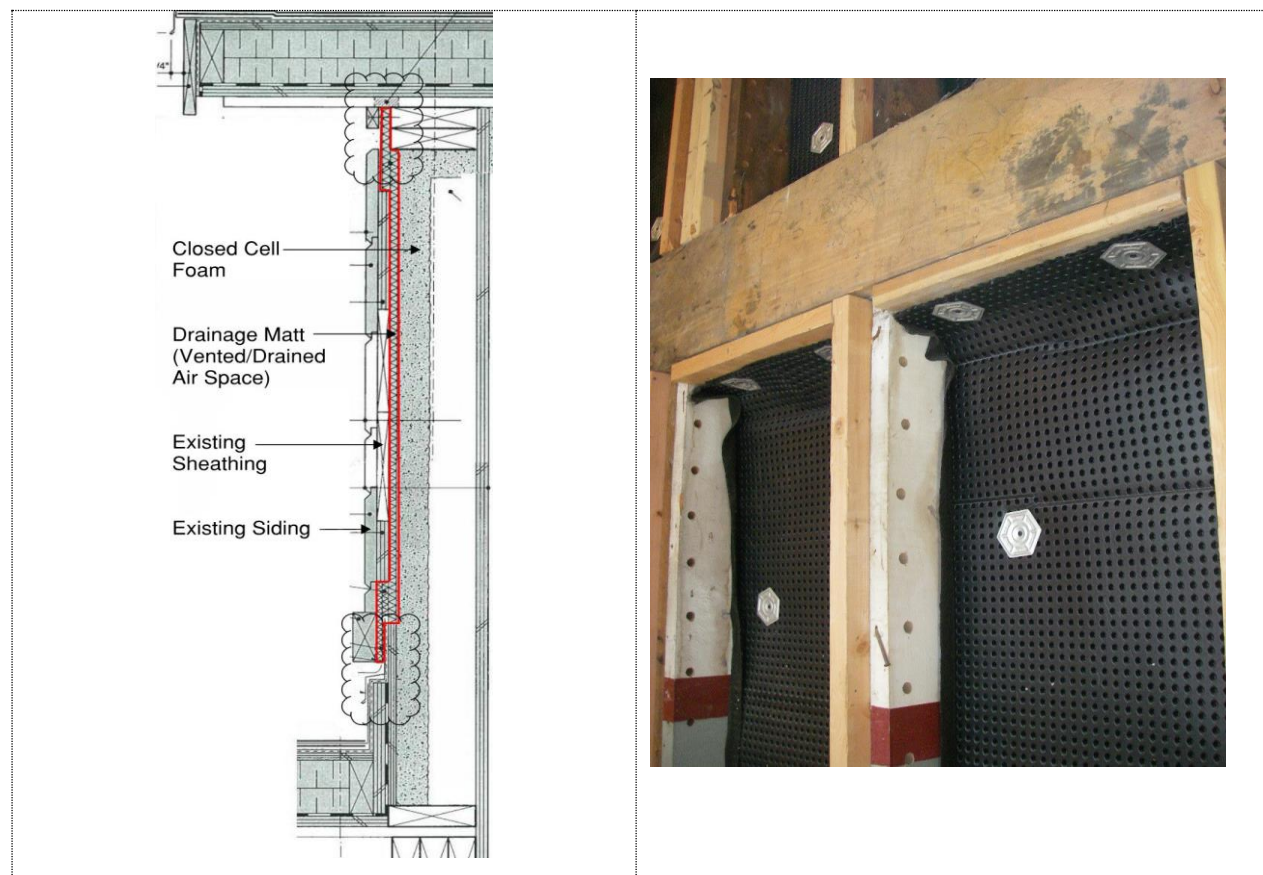
*Figure 3 & Photo 11: Drainage mat detail at the top and base of wall and at the stud transitions*

With the design team on board with the concept, the details were drawn for implementation on site. But similar to most construction projects, things do not always go as planned nor are they as simple as originally anticipated. There were additional details to be developed, such as where the walls met a sloped roof at the base, around windows and other penetrations, and where structural members interrupted the cavity. Some examples of these details are presented below (Figure 3 and Photo 11).

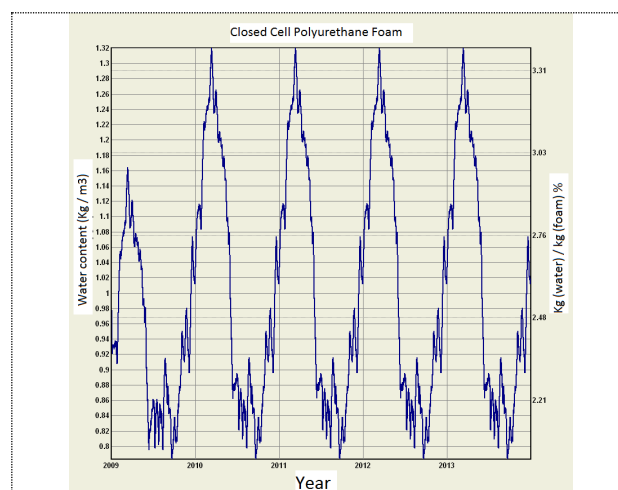
Graph 1: MC of foam

Graph 1 shows the moisture content of the spray foam from 2009 until 2014. During this five-year period, the moisture content of the foam has increased during the cold seasons and then has decreased during the warm seasons. There has not been an escalating moisture accumulation rate in the foam and the moisture content (MC) of the foam at the end of each year stayed the same throughout the five-year period. It should be noted though that for buildings with high interior moisture generation rates, the use of low permeance drainage mat on the cold side of the foam insulation requires caution since the risk of sustained moisture accumulation in the spray foam could potentially be increased.

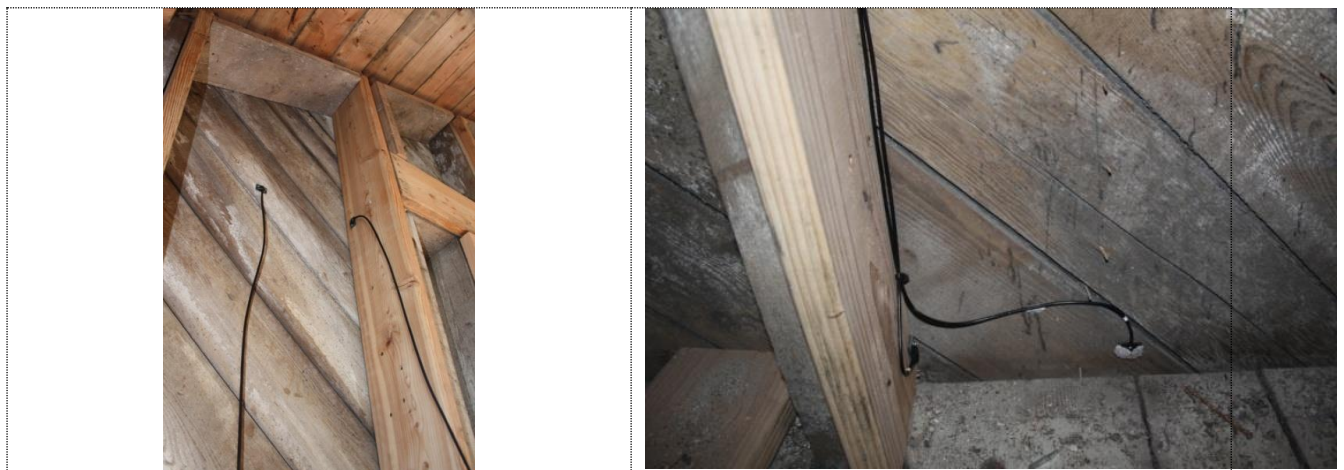
*Photos 12 & 13: Moisture and temperature sensors at the existing sheathing and studs*

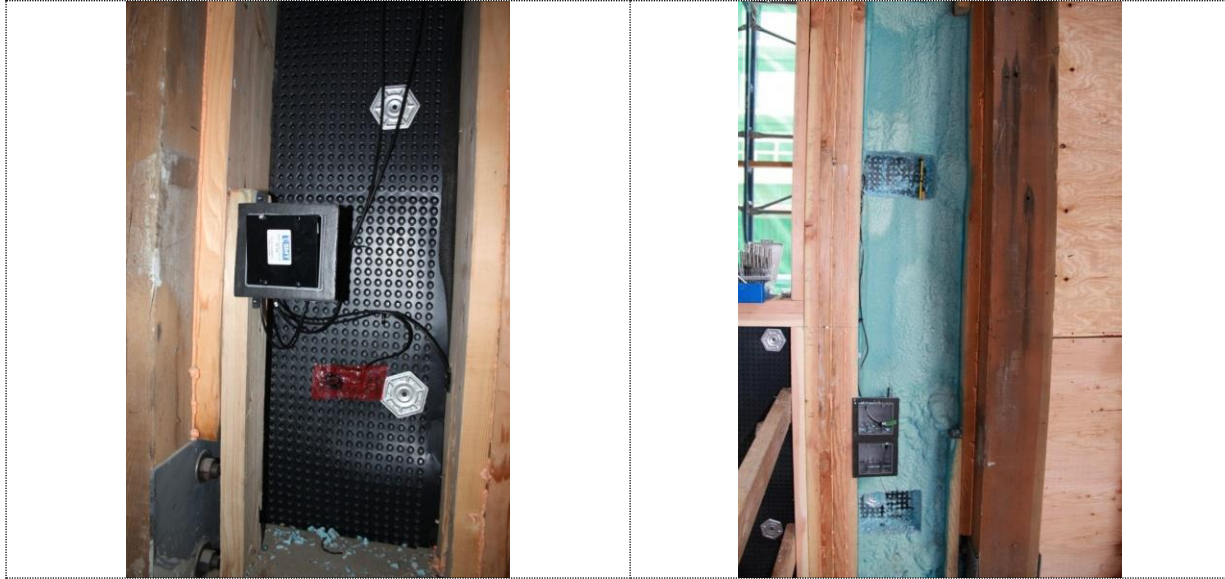
*Photos 14 & 15: Upon installation of the sensors, drainage mat and foam were installed*

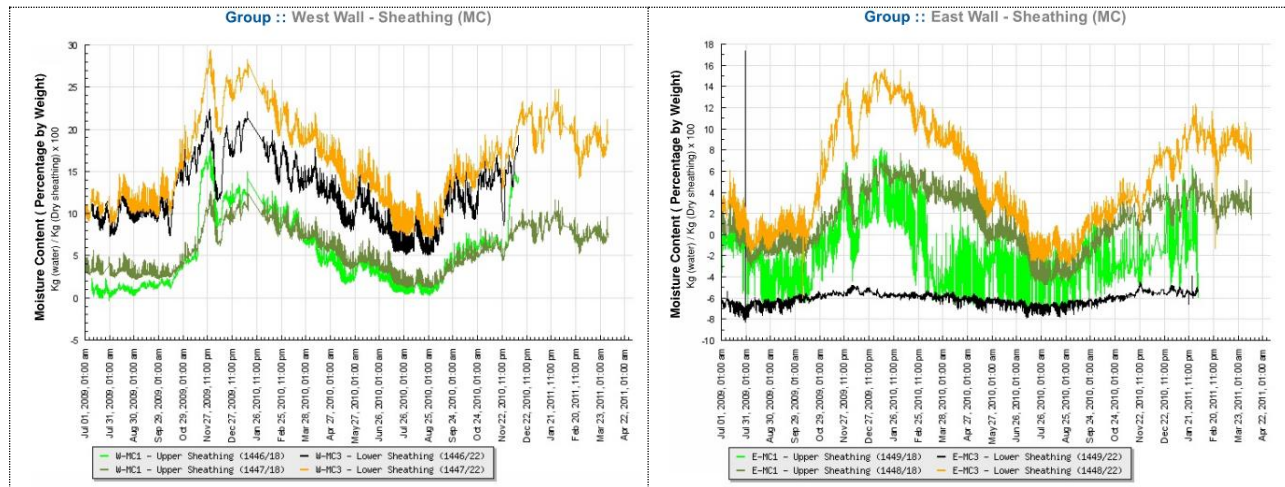
Graphs 2 & 3: MC of sheathing at west and east elevations

The moisture content (MC) readings of the sheathing at the west and east elevations are presented in Graphs 2 and 3. The MC of the sheathing has fluctuated throughout the year with increased MC during the winter months and decreased MC for the rest of the year. For example, the MC of the lower sheathing at the west elevation goes up to 28% in November 2009, and then it manages to go down to 10% in July 2010. The MC of the lower sheathing at the east elevation follows a similar trend: it goes up to 15% in January 2009 and then goes down as low as 10% in July 2010.

Interestingly, while most of the wind driven rain in Vancouver is from the east, it is the west elevation that experiences the higher moisture content at the sheathing level. The west elevation also happens to be an elevation that does not incorporate a moisture barrier (as opposed to the east elevation which does). One could speculate that the moisture barrier does in fact provide a certain level of protection for the sheathing. In any case, a fluctuation of the MC in the sheathing is expected since the moisture content is closely related to relative humidity of the air. During the winter, the relative humidity of the outside air is higher than that during the rest of the year. This will result in increased MC of the sheathing during winter [6]. The graphs indicate that although the sheathing gets wet during the winter, it managed to dry out during warmer weather. As long as the wetness is not sustained over a long period and drying can take place effectively, there would not be a concern with regard to moisture damage due to high MC.

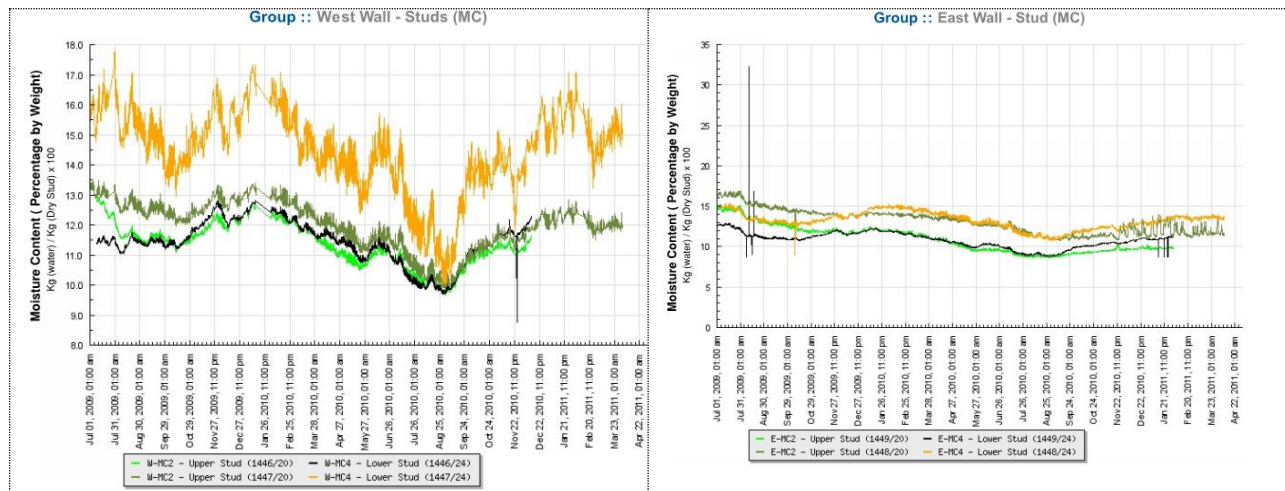
Graphs 4 & 5: MC of studs at west and east elevations

The MC readings of the studs at the west and east elevations are presented in Graphs 4 and 5. As shown in these graphs, the MC of the studs has been below 19% for the majority of the year and has decreased since the start of monitoring. The MC of the studs is relatively stable without significant fluctuations.

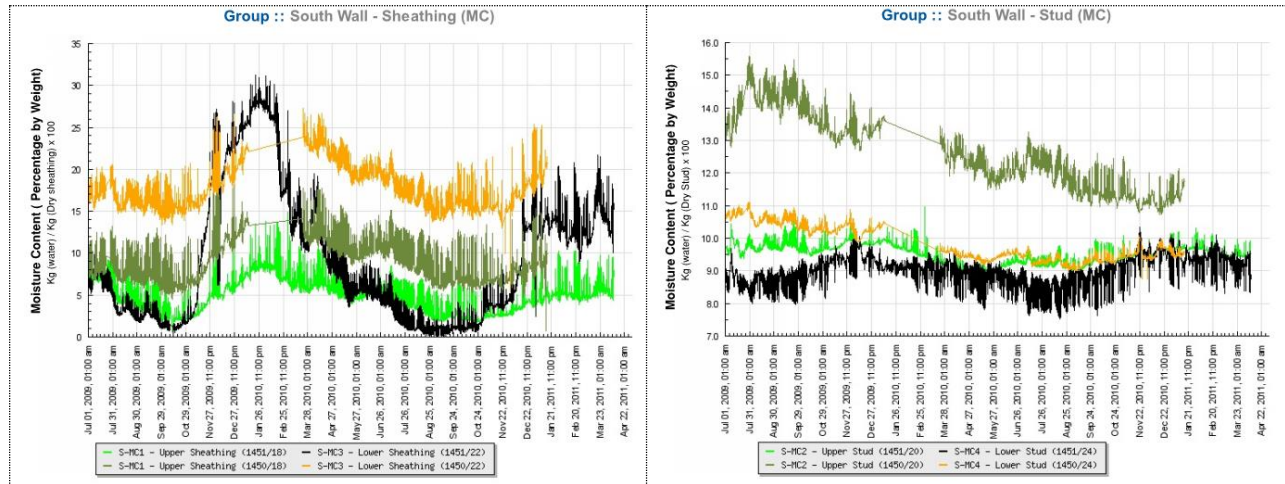
Graph 6 & 7: MC of sheathing and studs at south elevation

As discussed earlier, during construction, it was decided that the existing siding should be removed and replaced with new on the south elevation. As a result, the drainage mat strategy was not incorporated for the south elevation and instead, a spun bonded polyolefin fabric was installed over the existing diagonal sheathing, with new or reused horizontal siding installed over that. Graphs 6 and 7 show the MC readings of the sheathing and studs at this elevation. The results follow similar trends as observed at west and east elevations. The collected data on the north elevation was not conclusive and is not included here.
