# IMPLEMENTING COMPARTMENTALIZATION AND VENTILATION STRATEGIES IN TALL MULTI-USE BUILDINGS TO CONTROL STACK-EFFECT RELATED PERFORMANCE ISSUES

David De Rose, M.A.S.C., P.Eng.

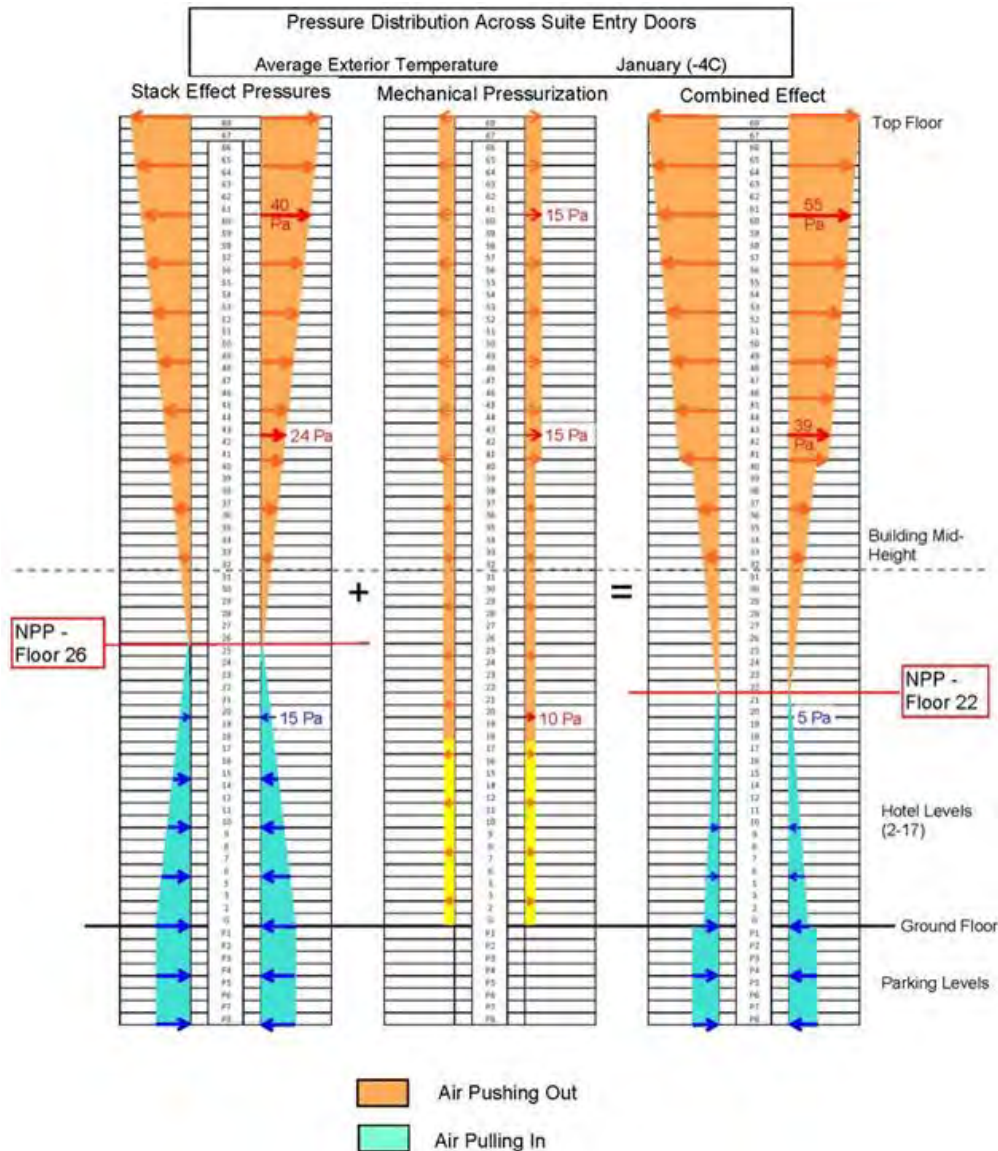
Pressure readings taken with and without the corridor pressurization systems operating determined that the corridor air pressures created by the mechanical ventilation system were between 10 to 15 Pa. The stack effect pressures significantly affected ventilation air delivery to the suites. Figure 1 shows the average pressure differences across the suite doors on Floors 20, 43, and 61 during average January exterior temperatures to be: -5 Pa, 39 Pa, and 55 Pa respectively. The flow is from the suites into the corridors on the 20<sup>th</sup> floor indicating that the ventilation pressures are overcome by the stack effect pressures. We expect this to be the case on all floors below the 22<sup>nd</sup> floor during average winter conditions. On the 43<sup>rd</sup> and 61<sup>st</sup> floors, the measured pressures across the suite doors are roughly 3 to 4 times higher than the pressures created by the ventilation system. This correlates with the thermographic scan that identified air flow through open bathroom and kitchen exhaust grille flaps in the suites above the neutral pressure plane (even when exhaust fans were off).

The pressures measurements on the different floors indicated that the corridor ventilation system is not effectively or efficiently ventilating the suites. The upper suites are over-ventilated and the lower suites are under-ventilated.

Figure 1: Pressure Distribution across Suite Entry Doors

This strategy would include implementing air seals between the suites and corridors and adding Energy Recovery Ventilators (ERV) so that window or door operation in one suite does not affect air flow or ventilation air flow in other suites. The ERV systems could be ducted and integrated into the existing exhaust fan duct layout to provide ventilation air from outside directly to each suite. This would lead to smaller variations in the amount of ventilation air flow delivered to suites. Indoor air quality would be improved since air delivered to a unit is not likely to have travelled through other parts of the building. Environmental conditions in the suites would be improved (i.e. they would not be too dry from over-ventilation or excessively humid from under-ventilation). Energy savings are also expected from not pushing excessive amounts of air out of exhaust duct runs in suites above the NPP. The garage area would also be neutralized as a source of air being delivered to the suites.
