Vertical Movement Monitoring in Six-Storey Wood-Frame Building in British Columbia

March 2016

Jieying Wang, Senior Scientist, Structural, Durability & Sustainability Group

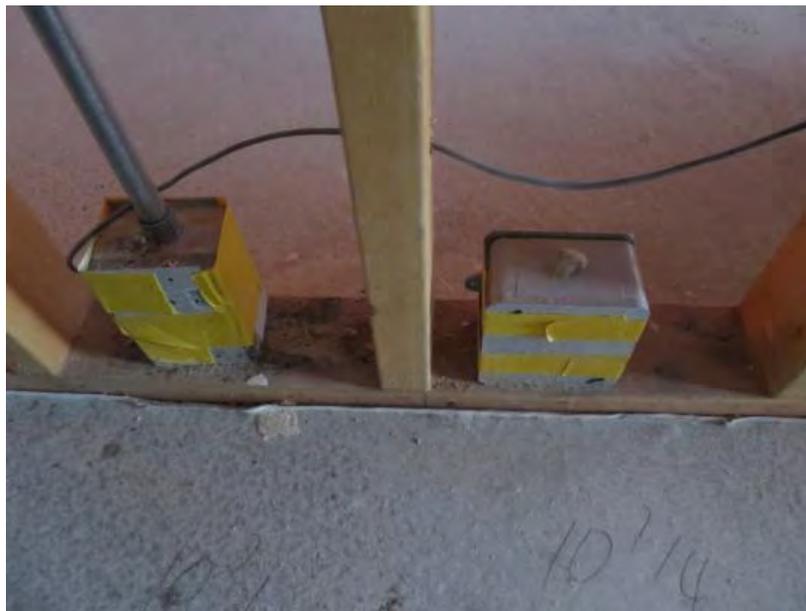
Figure 1 Displacement sensor boxes sitting on the bottom plate of an interior partition wall

Instruments were installed based on the established monitoring systems and protocols used in the previous studies (Wang *et al.* 2013; Wang and Ni 2014), after the roof was sheathed and before the walls were closed in. The locations of monitoring were determined based on input from the project structural engineer. A central suite in the building was chosen for instrumentation. A wire displacement sensor (Model WPS-50-MK30-P50, with a range of 25 mm) was used to measure vertical movement. One sensor was used to measure each floor, installed on the sill or bottom plate, extending upwards in a stud cavity, and then through the top plates, floor and bottom plates above (Figure 1). Three lines of displacement sensors were installed to measure the vertical movement at a party wall, a corridor wall, and an interior partition wall from the first floor to the sixth floor (Appendix I, Figure 10). The sill plates were not measured. The party wall, being a shear wall, was a double-stud wall built with nominal 2 in. by 4 in. (actual 38 mm by 89 mm) dimensional lumber and had plywood sheathing pre-installed on one side. The displacement sensors were installed in a stud cavity of the wall without plywood sheathing. The corridor wall, also a shear wall, was built with staggered studs using nominal 2 in. by 4 in. dimensional lumber and with plywood sheathing pre-installed. The sensors were installed close to the sheathing side. The interior partition wall was built with nominal 2 in. by 4 in. dimensional lumber

without plywood sheathing. Displacement sensors were also installed on the bottom two floors of the exterior wall, built with nominal 2 in. by 6 in. (actual 38 mm by 140 mm) dimensional lumber and had plywood sheathing pre-installed.

Only two floors were chosen since the exterior wall did not have many clear stud cavities available for instrumentation due to the large windows in the wall. Monitoring the exterior wall became a lower priority since the previous monitoring had shown that exterior walls had considerably smaller amounts of vertical movement compared to interior walls resulting from differences in wood MC and load (Wang *et al.* 2013; Wang and Ni 2014). Spacing between studs at the measurement locations varied. The linear design loads for these four locations are provided in Appendix II, Table 3. For each displacement sensor, the stainless wire used to extend the draw wire of each sensor to measure the movement over each floor was protected with a 1/2 in. (13 mm) metal conduit. Effort was made during the installation to ensure that each conduit was vertically aligned. Each displacement sensor was wired individually to a data logger located in the electrical closet on the fourth floor. A computer was installed nearby to transmit data hourly.

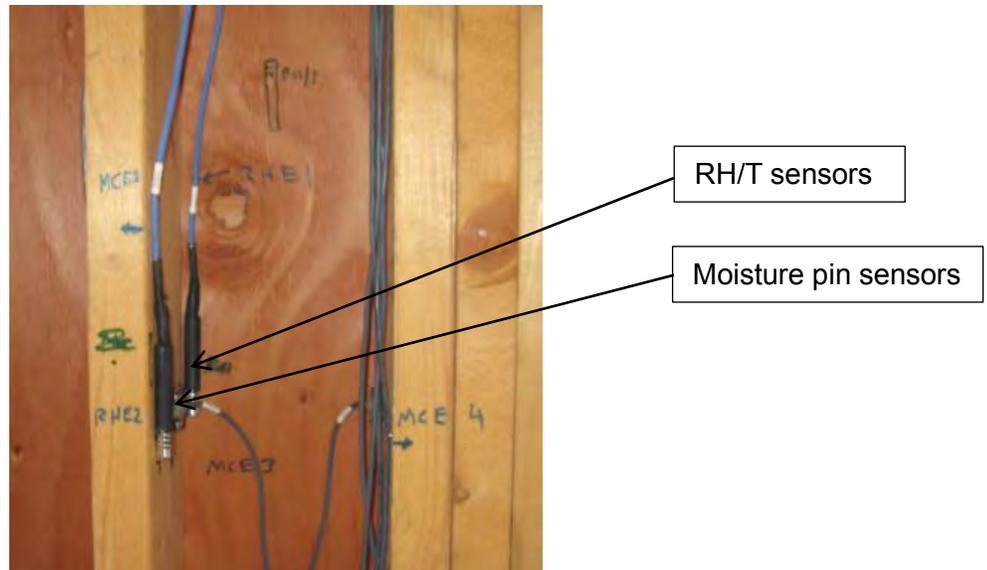
Figure 2 Moisture pin sensors and RH/T sensors installed at chest height on the interior side of an exterior wall

Resistance-based moisture pin sensors and RH/T sensors (for measuring ambient relative humidity (RH) and temperature) were installed in the suite on the first floor to measure wood MC as well as the environmental conditions in service, including locations with the highest moisture risk. Four moisture sensors were installed to measure the MC at specific locations in the exterior wall. Two of them were placed on the studs at chest height, being in mid-depth of the 2 × 6 in. dimensional lumber (Figure 2); two others on the sill plate, with one sensor being deeper in the plate (i.e., adjacent to the concrete curb) and the other being central in the sill plate. Within the same stud cavity, two RH/T sensors were installed at chest height to measure the service environment close to the exterior plywood sheathing and the interior drywall, respectively (Figure 2). In a similar way, four moisture sensors were installed in the interior partition wall to measure MC of the sill plate and two studs above, together with two RH/T sensors at chest height to measure the environmental conditions in the stud cavity, i.e., the indoor environmental conditions.

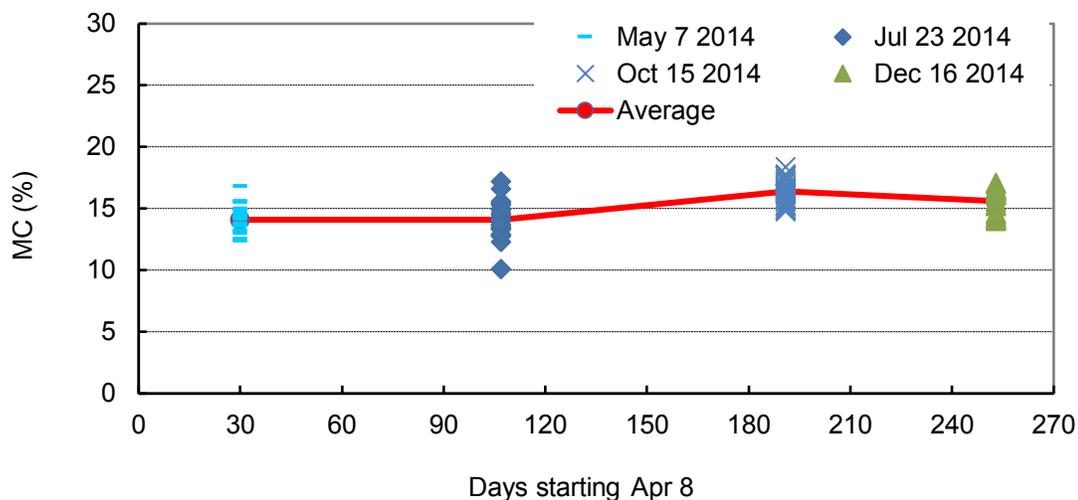
Figure 3 Average moisture content of dimensional lumber based on measurements using a hand-held capacitance meter during framing

The MC measurements on site visits during framing indicated that the differences in MC between wall plates and studs, or among the different floors of the building, were very small. Climate data showed that the early summer (May, June) of 2015 was much drier, with dramatically reduced precipitation, than normal weather conditions (the average temperature and precipitation data for May, June, and July from 2011 to 2015 are provided in Appendix III, Figure 11). The average MCs of studs measured during four site visits are shown in Figure 3. The results were consistent with those from the similar summertime measurements in a previous study (Wang and Ni 2014), with an average MC of about 15% throughout the framing stage. The weather became relatively wet when the walls were being enclosed (October-December, 2014) but the MC of wood did not appear to have increased significantly and there was no need for space heating. The weather conditions during framing are the most important factor for on-site moisture management. The wood is well protected against rain-induced wetting once the roof and exterior walls are covered with water-proofing membranes.

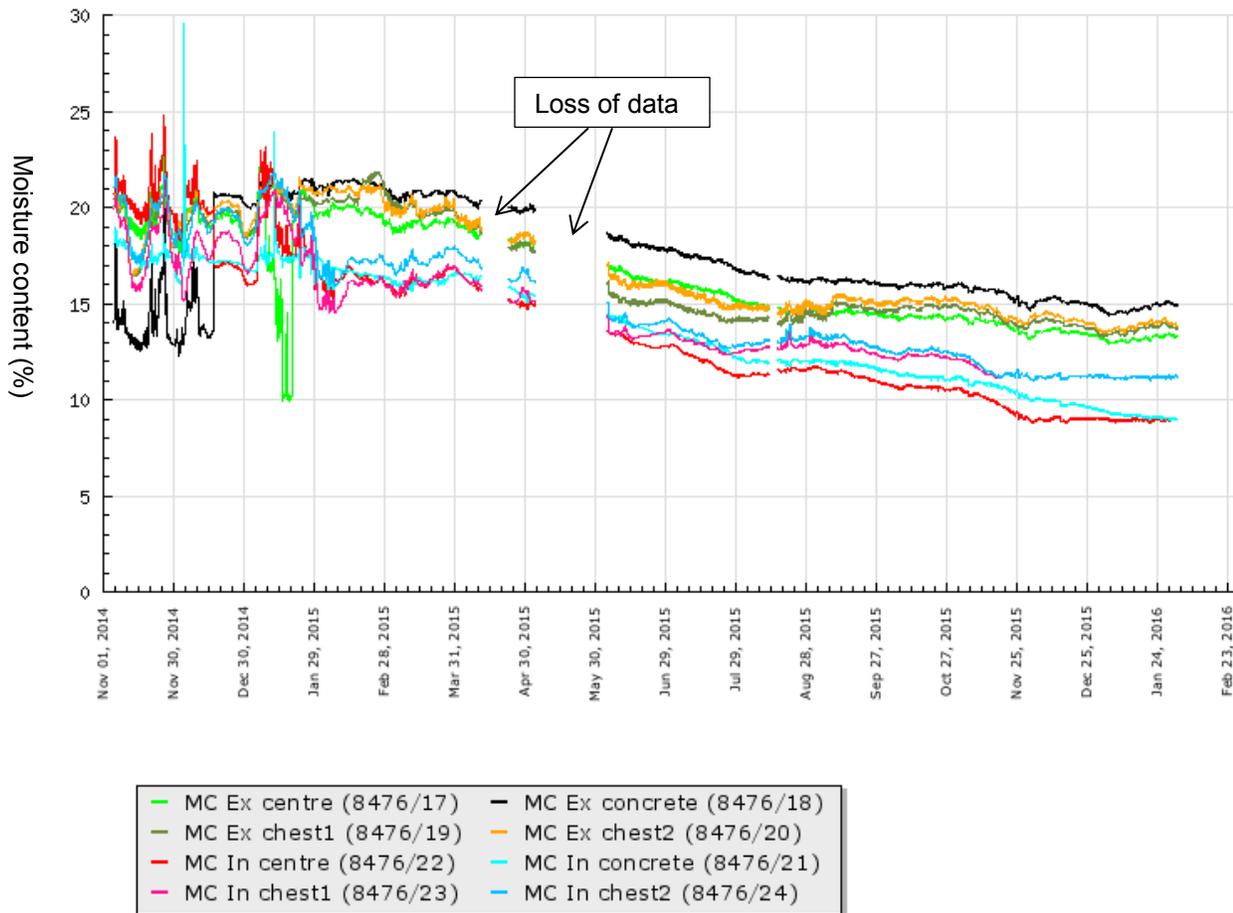
Figure 4 Moisture content measurements in the exterior wall and the interior partition wall on the first floor based on electrical resistance-based sensors

(Chart legends: “MC” means “moisture content”, “Ex” means “exterior wall”, “In” means “interior partition wall”, “concrete” means “being adjacent to the concrete curb”, “centre” means “in central sill plate”, and “chest” means “at chest height”.)

MC changes from construction to service for the different locations in the exterior wall and the interior wall on the first floor are shown in Figure 4 based on the installed resistance-based moisture pin sensors. In general, the MC reduced from a range between 15% and 20% when the roof sheathing was installed, to a range from 9% to 15% half a year into building service. The wood dried very slowly. Different from the capacitance-based meter used at the framing stage, each moisture sensor measures MC at the specific location. It was found that the MC readings from the exterior wall were overall higher than those measured from the interior wall, and those measured from the sill plates were higher than those from the studs at chest height.

Note that the readings from the moisture pin sensors discussed above had not been specifically calibrated for the wood species (Douglas-fir or lodgepole pine) based on the measurement tool and they might slightly be reduced once calibrated. Taking the relatively stable RH of around 60% at a temperature of about 20°C in the summer (May-August) as an example, wood on average should theoretically achieve an equilibrium moisture content of approximately 11% under such an ambient condition (FPL 2010). But the readings from the pin sensors ranged from 12 to 18% depending on locations and wood species. Although it is understood that the wood may not have reached equilibrium, it appeared there could be a discrepancy between measurements and actual values. The ongoing calibration study is expected to shed light on this when it is completed.

- The moisture sensors installed to measure the MC on the first floor of an exterior and an interior wall, covering locations with the highest moisture risk such as sill plates, showed that the MC of the dimensional lumber slowly decreased from a range of 15 to 20% when the roof sheathing was installed, to a range of 9 to 15% half a year into service.

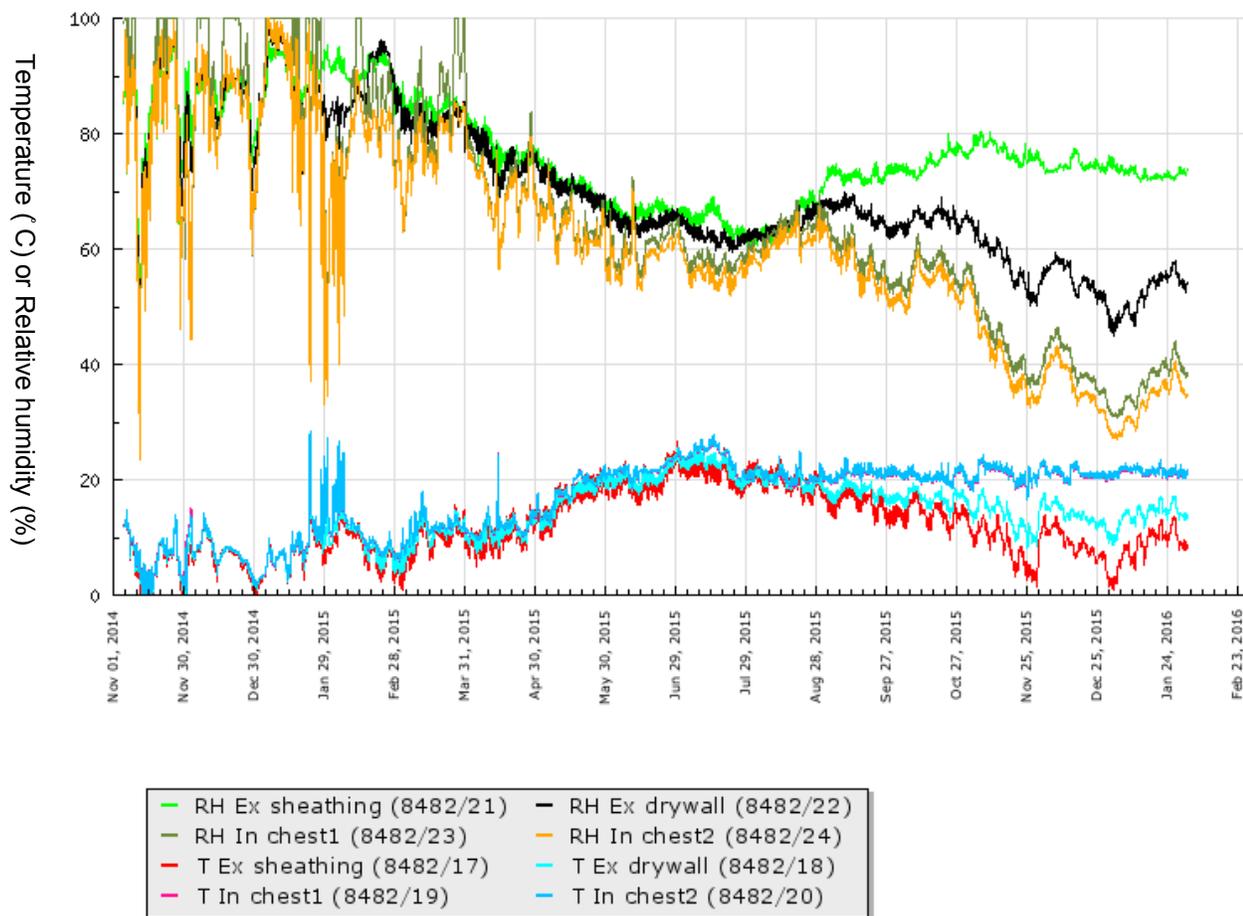
Figure 5 Changes in relative humidity and temperature in the exterior wall and the interior partition wall on the first floor

(Chart legends: “RH” means “relative humidity”, “T” means “temperature”, “In” means “interior partition wall”, “concrete” means “being adjacent to the concrete curb”, “centre” means “in central sill plate”, and “chest” means “at chest height”).

Closely relevant to wood MC changes, the measurements of RH and temperature showed service environmental conditions for those wood elements (Figure 5). It was found that the ambient service environments were similar between the exterior wall and the interior wall in the summertime (June-August) when occupancy just started (and air conditioners were not used). The indoor RH measured from the interior partition wall had dropped greatly since September, with the start of the heating season. Compared to the warmer and drier conditions in the interior walls, it generally became colder and damper (i.e., higher RH) in the exterior wall. The RH on the drywall side of exterior walls reduced much more slowly with considerably higher readings compared to the interior wall conditions. On the exterior sheathing side, the measurements had actually showed a trend of increase in RH from September, with the readings occasionally approaching 80%. This environment appeared to be mostly influenced by the exterior weather conditions. These measurement results confirm the higher durability risk that exterior sheathing typically experiences in a heating climate (especially when there is no insulation installed to the exterior of the sheathing). The monitoring study also implies that the riskier locations, which tend to trap moisture and to dry slowly (e.g., sill plates) or are in a damper service environment (e.g., exterior sheathing), deserve more attention in design and during construction to reduce wetting and to promote drying to ensure long-term durability of the wood elements.

- As expected, the *in-situ* monitoring showed that it was colder and damper in the exterior wall in the winter season, particularly at locations close to the exterior sheathing, compared to the warmer and drier service conditions of the interior walls.

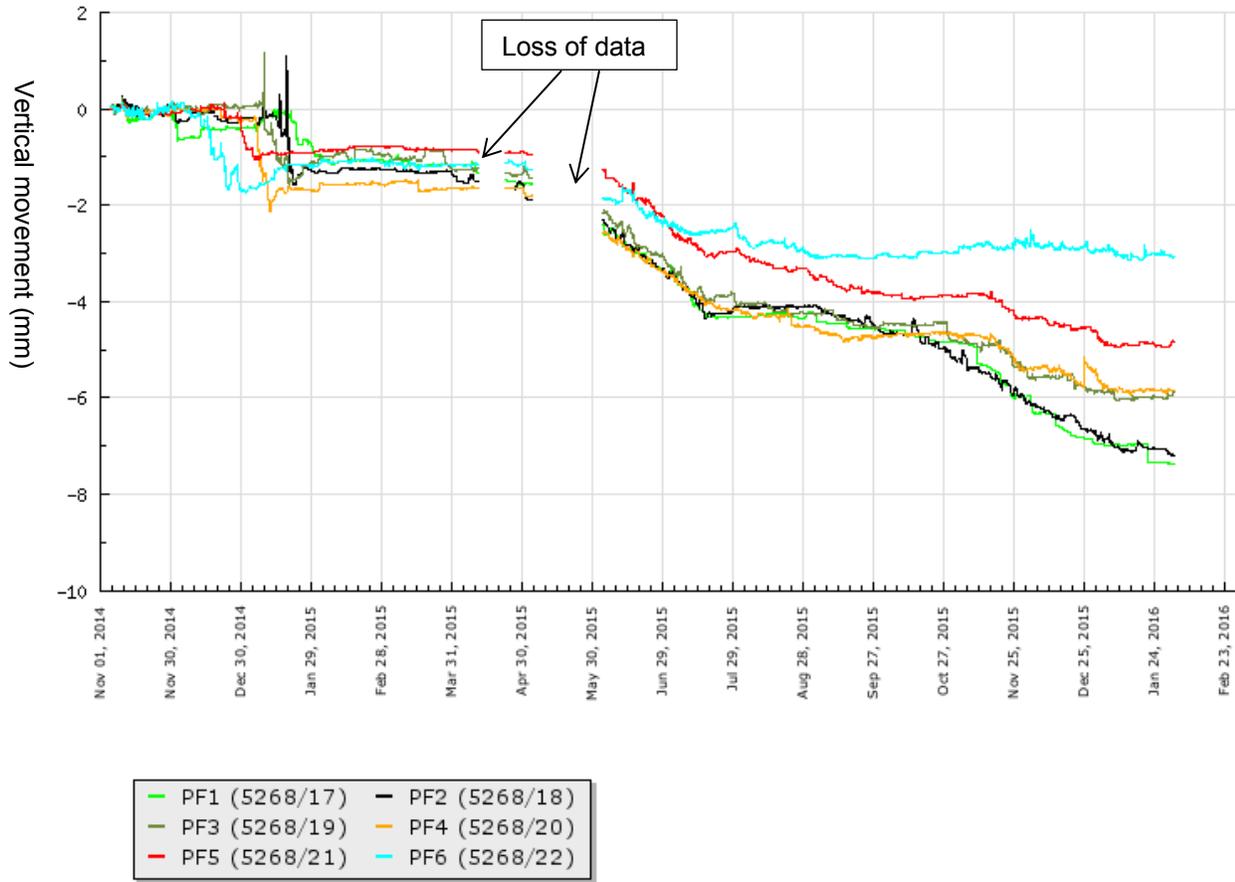
Figure 6 Movement measurements from sensors installed in the party wall

(Chart legends: “PF” means “party wall”, the number in each label means the floor level. Negative readings indicate downward movement.)

the results from the two previous monitoring studies (Wang *et al.* 2013; Wang and Ni 2014), this study showed that the vertical movement amounts were generally higher in the interior walls than in the exterior wall, and higher on bottom floors than on upper floors (Figure 6 – Figure 9). Such differences are believed to be mostly caused by differences in wood MC and load.

The curves in Figure 6 – Figure 9 showed high fluctuations and considerable amounts of downward movement during the construction between November 2014 and January 2015. Drywall and other interior and exterior finishing were installed, greatly increasing dead loads, together with large live loads and localized vibrations due to construction activities. But the wood was not drying significantly based on readings from the moisture pins installed (Figure 4). Afterwards the downward movement at each location greatly increased from May to July, when the construction was being completed and the building gradually occupied. Aside from a small effect of load, those dramatic increases in vertical movement must have been primarily caused by wood drying resulting from the drier service environment. This was partially confirmed by the measurements of wood MC and ambient humidity conditions on the first floor (Figure 4, Figure 5). The dry weather in 2015 (Appendix III, Figure 11) appeared to have led to relatively rapid wood drying and consequently greatly increased downward movement.

- The measured movement over the entire height (from top of foundation to underside of roof trusses) reached 35 mm at the party wall, 39 mm at the corridor wall, and 39 mm at the interior partition wall after 15 months of monitoring (i.e., after the roof sheathing was installed). The movement of the exterior wall appeared to be smaller, based on measurements on the bottom two floors.

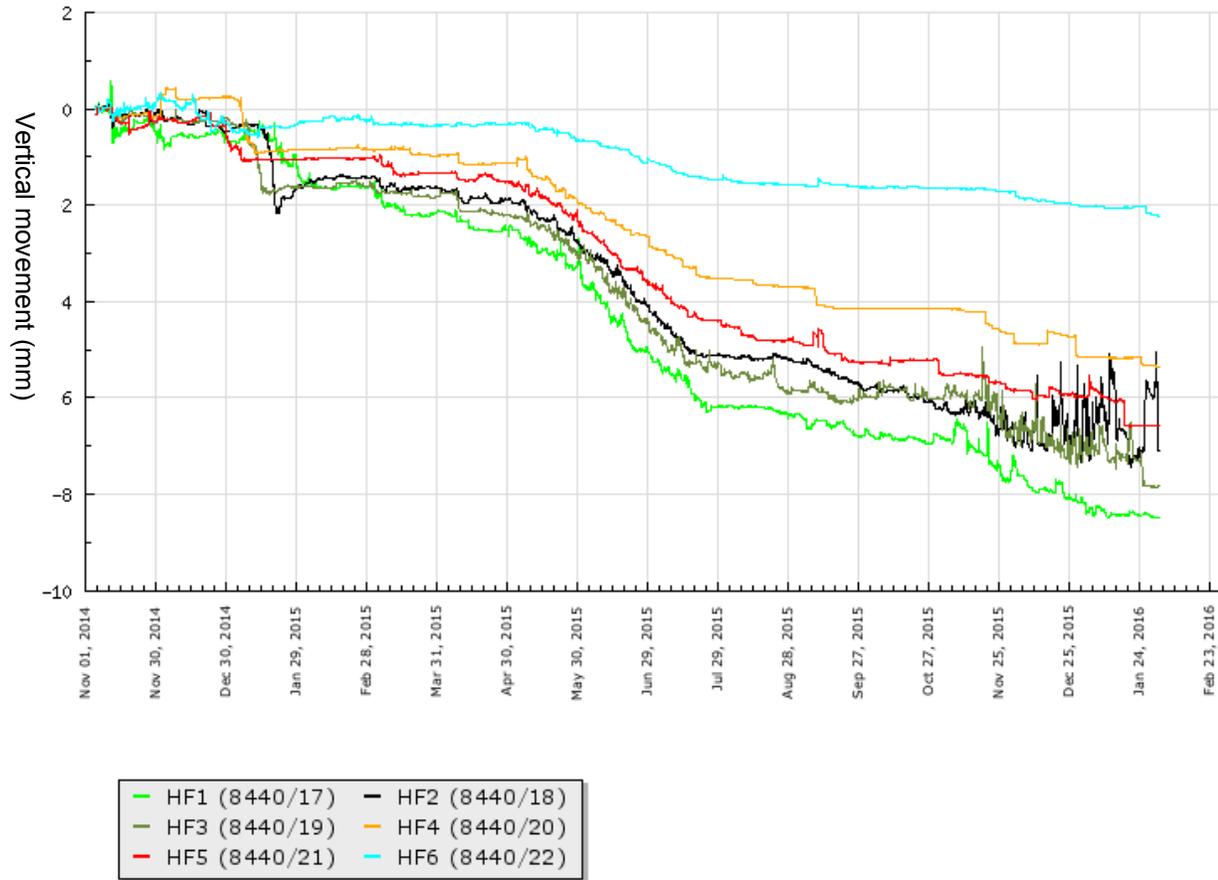
Figure 7 Movement measurements from sensors installed in the corridor wall

(Chart legends: “HF” means “corridor wall”, the number in each label means the floor level. Negative readings indicate downward movement.)

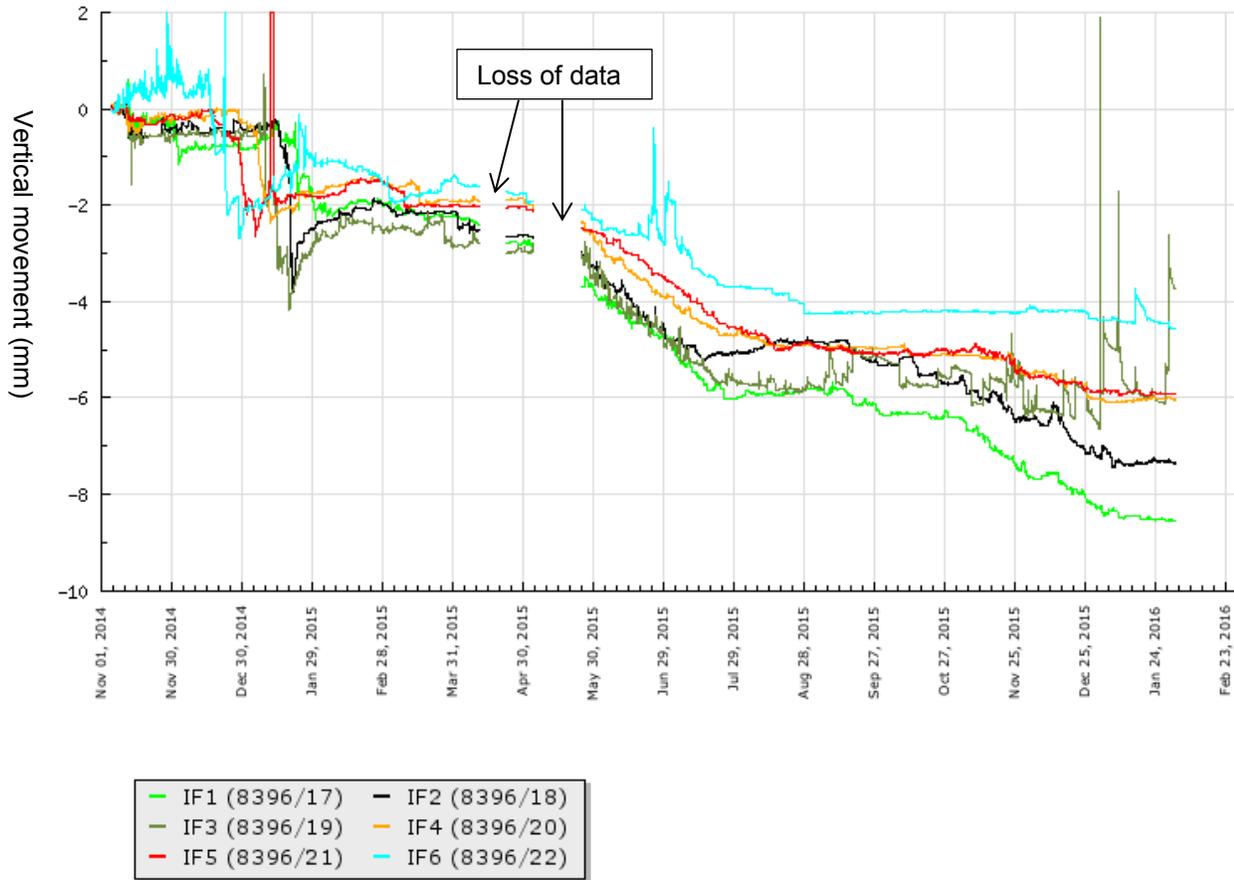
Figure 8 Movement measurements from sensors installed in the interior partition wall

(Chart legends: “IF” means “interior partition wall”, the number in each label means the floor level. Negative readings indicate downward movement.)

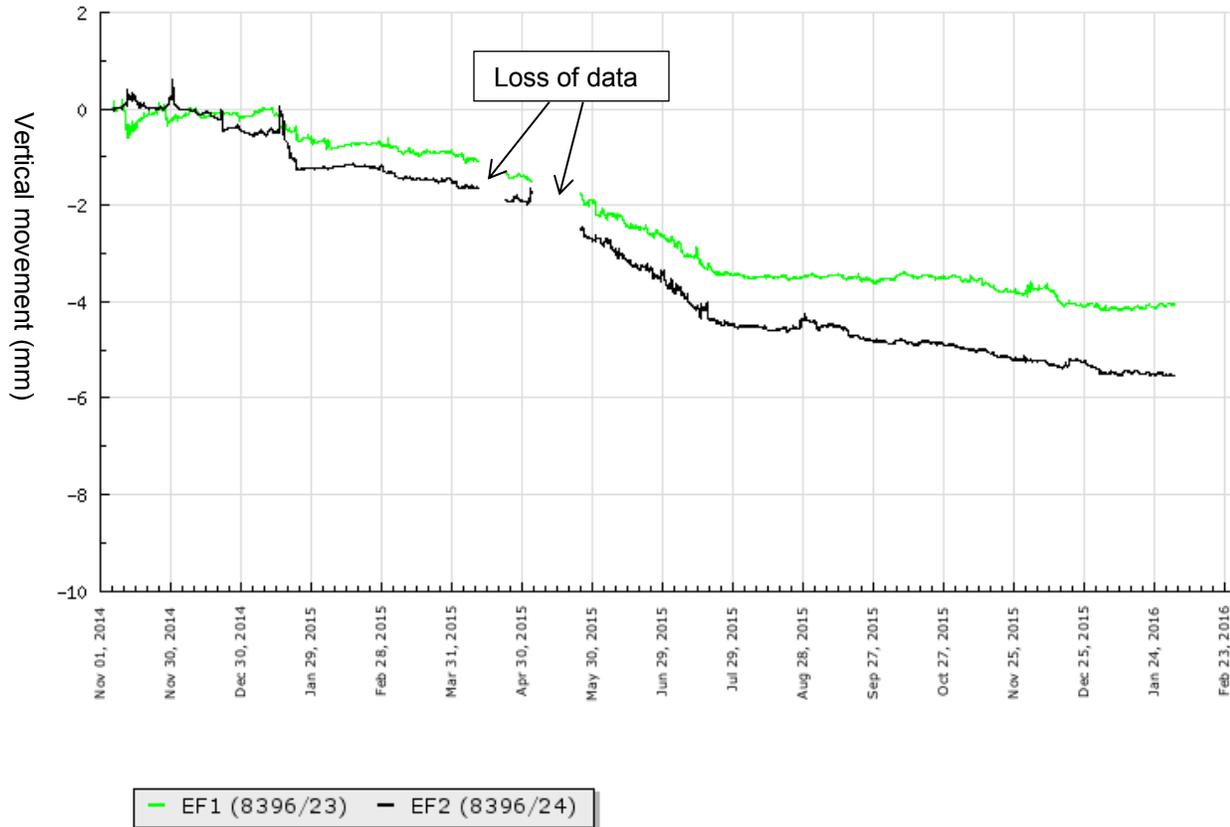
Figure 9 Movement measurements from sensors installed in the exterior wall

(Chart legends: “EF” means “exterior wall”, the number in each label means the floor level. Negative readings indicate downward movement.)

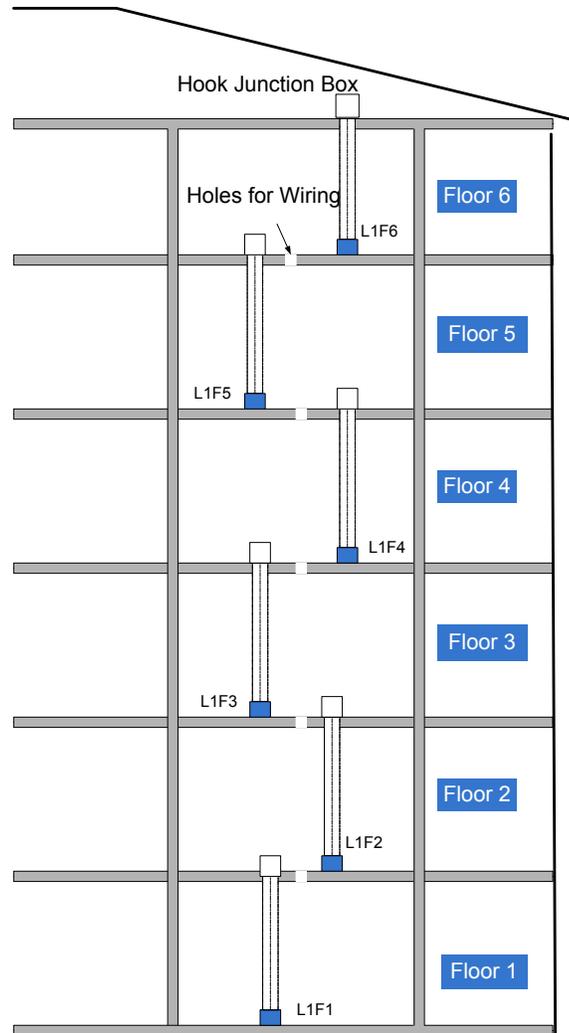
Figure 10 An elevation to illustrate displacement sensors installed on each floor

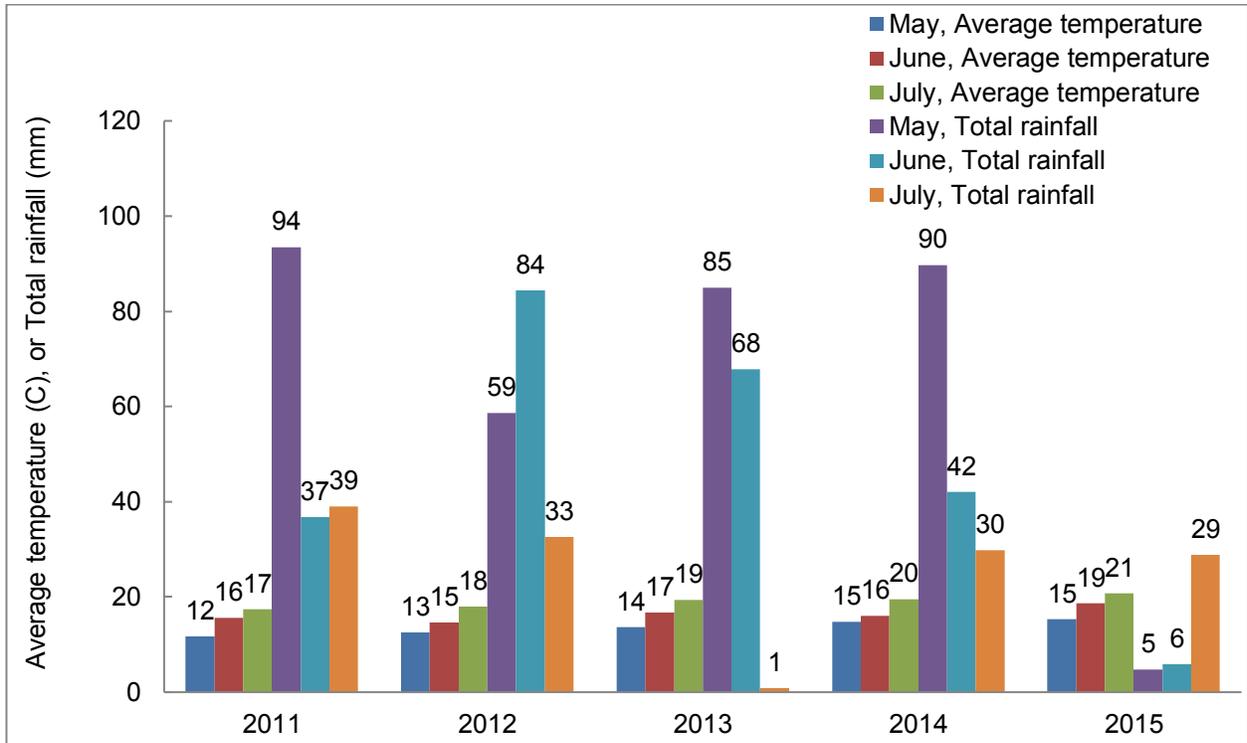
Figure 11 Average monthly temperatures and total rainfall amounts in May, June and July from 2011 to 2015²
